AFCEC-CX-TY-TP-2013-0006

## **EXPERIMENTAL INVESTIGATION OF WIDESPREAD DELAMINATION DAMAGE TO COMPOSITE MATERIALS CAUSED BY RADIANT HEATING**

June 2013

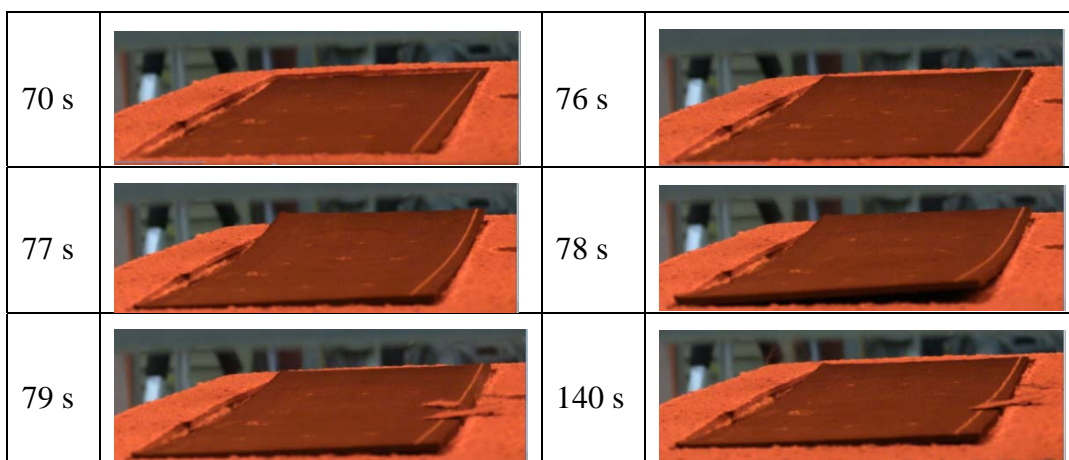
Infrared imaging of the plates immediately following removal from the heat source show uneven cooling of the plate surface, as would occur with delaminated regions. Images typically showed a few large and many small regions with greater cooling than surrounding material, as shown for plate A9 in Figure 9. Most regions of greater cooling were away from the edges of the plate, indicating that edge delamination was not the likely cause of initiation. There was also no evidence that delaminations originated in the region of embedded thermocouples. The larger regions sometimes showed swelling after cooling. These observations indicate that some delaminations grew to cover large regions of the plate, as later observed in plate sectioning.

Figure 7. Plate A9 (1.15 % moisture content) during delamination at  $35.2 \text{ kW/m}^2$ .

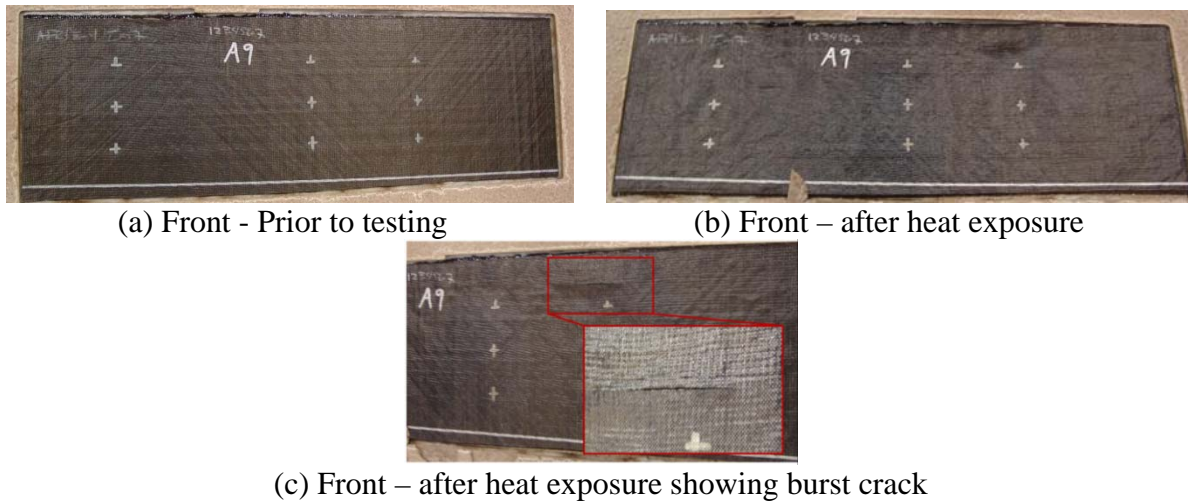
Damage varied from some by material type and heat flux. Visible damage to delaminated plates included discoloration, raised (bubbled) regions, burst cracks (front and back), and no visible pyrolysis in cross-section microscopy. Mass loss was less than 2 percent. Some delaminations were seen with very little surface damage. Examples of some damage modes are shown in Figure 8.

Figure 8. Plate A9 (1.15 % moisture content) before and after exposure at  $35.2 \text{ kW/m}^2$  for 152 s.

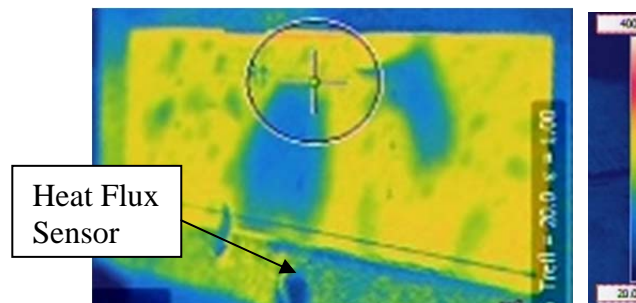
Figure 9. IR image of A9 (1.15 % moisture content) approximately 20 s after heat removal.

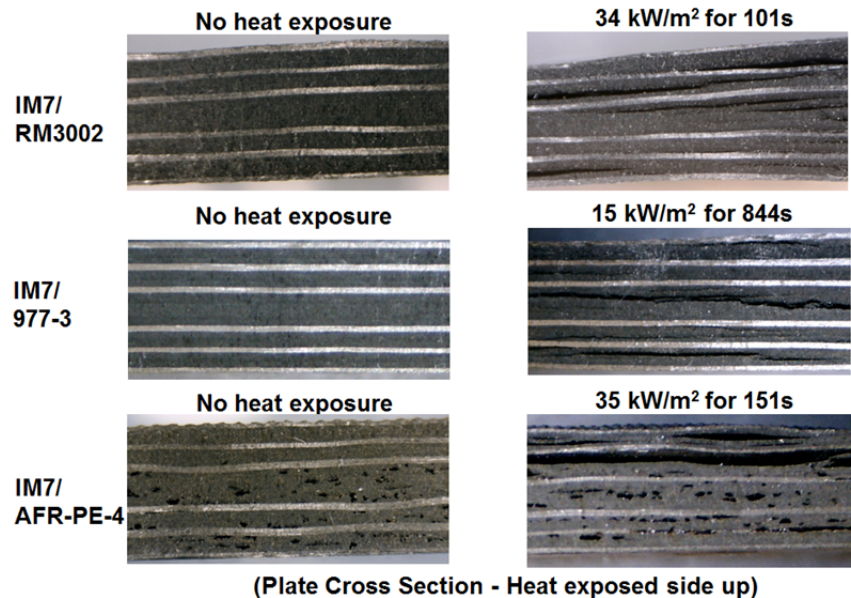
Optical microscopy was performed on all samples cut from the exposed plates. Widespread delaminations were evident throughout the thickness of the plates showing mechanical degradation. Exemplar cracks in each material are shown in Figure 10. There was no apparent pattern to where the delaminations occurred. Large widespread delaminations were seen throughout the thickness in the IM7/RM3002 and IM7/977-3 composites, but only on the plies on the heat exposed side of IM7/AFR-PE-4. Only small delaminations were seen on the unexposed side of this material. It is obvious that delaminations seen by the visual surface bubbling of the plates during testing were caused by the application of heat. However, it is possible that some of the delaminations throughout the thickness were also caused by the mechanical stresses caused by plate bending.

Figure 10. Microscopic images of plate cross-sections before and after radiant heat exposure.
